NIGHTRESPONSE INCIDENT REPORT

Account Number:	OC – 2175-208
Property Name:	Capistrano Village Center
Property Address:	32302 Camino Capistrano
City, State, Zip:	San Juan Capistrano, CA 92675

Incident Summary Description:	> Interior water leak
Incident Detailed Description:	Second floor restroom overflowed, leaked through floor into ceiling of office below
Detailed Location of Incident:	Second floor women's restroom first stall on far end
Third Party Vendor Copied on Report:	No
Which Utility Involved:	Sewer
Caller On-Site When Technician Arrived:	Yes
Other Parties Involved at Site:	No
Names & Positions of Other Parties:	N/A
Authorities Involved:	No
Which Authority:	N/A
Name of Responding Authority:	N/A
Contact Number for Responding Authority:	N/A
Photographs Taken and Attached:	Yes
Inventory Used:	Equipment only
Equipment Used and Kept On-Site:	Blower
Time Off of Property:	1/16/07 12:31 AM

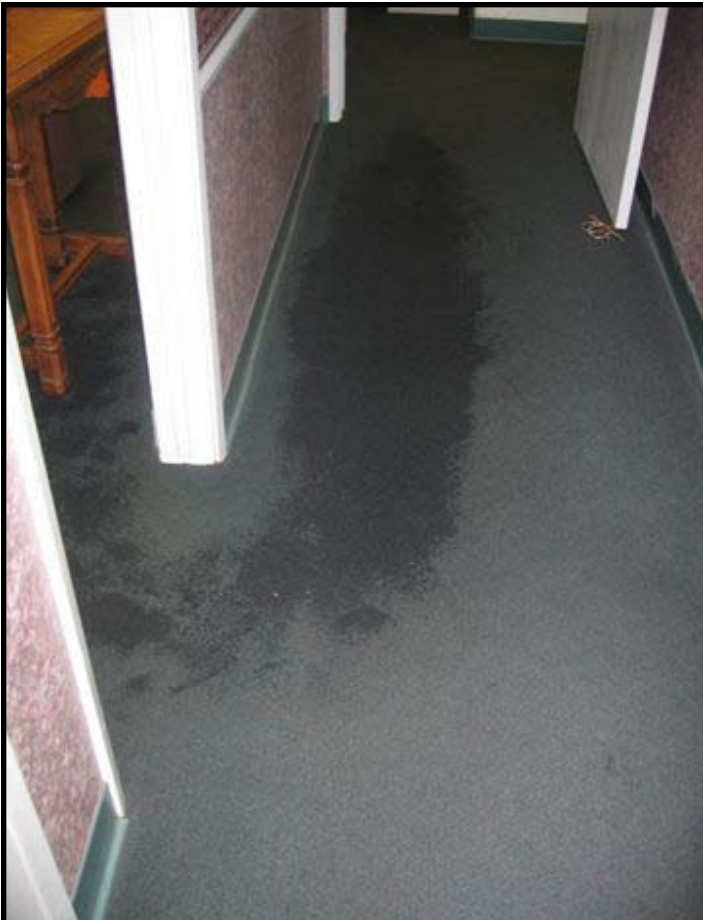
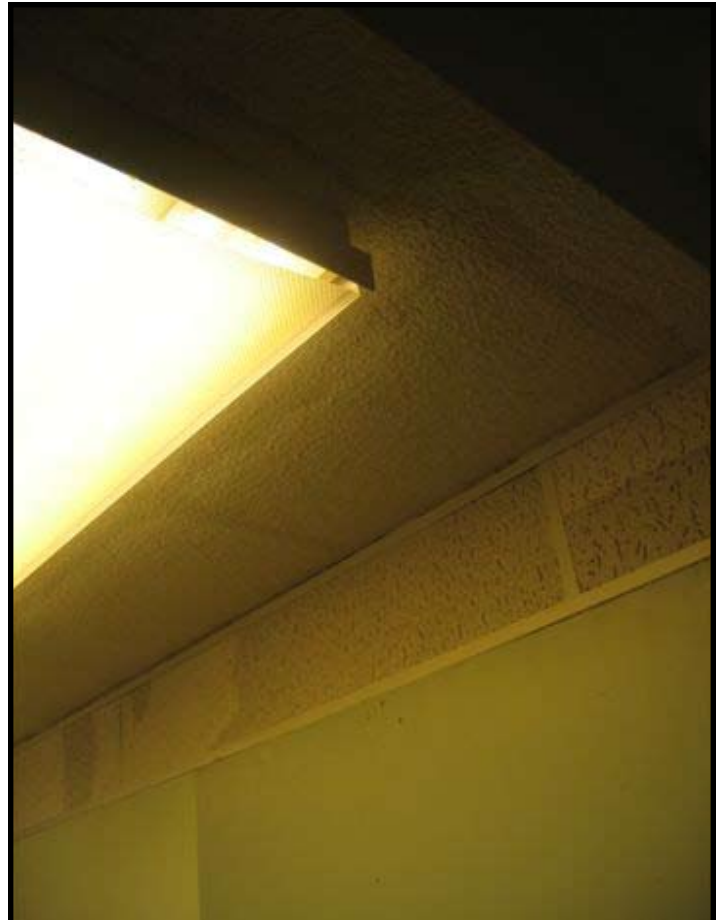
PHOTOS

Follow-up Urgency:	> Urgent
Property Status:	B - Damage Contained To A Small Area
Issue Status:	Issue mitigated by NR, damage halted, repair needed
Repair Status:	3rd party required
Detailed Description of Response:	Technician shut off toilet, cleared blockage (excessive paper), turned toilet back on, extracted water from restroom floor, cleared furniture from wet area in office below, removed standing water from carpet, set-up one blower to circulate air
Follow-up Direction for Manager	> Contact to evaluate damage in ceiling, may be able to be dried in place, floor needs to be professionally cleaned and disinfected
